**CITY OF ROCKVILLE HISTORIC DISTRICT COMMISSION
STAFF REPORT
for
March 16, 2006
MEETING NO. 3-06**

HDC2006-00347

ADDRESS: 25 – 33 Wood Lane

REQUEST: Remove all existing wood windows and replace with Anderson thermally-glazed vinyl-clad wood windows.

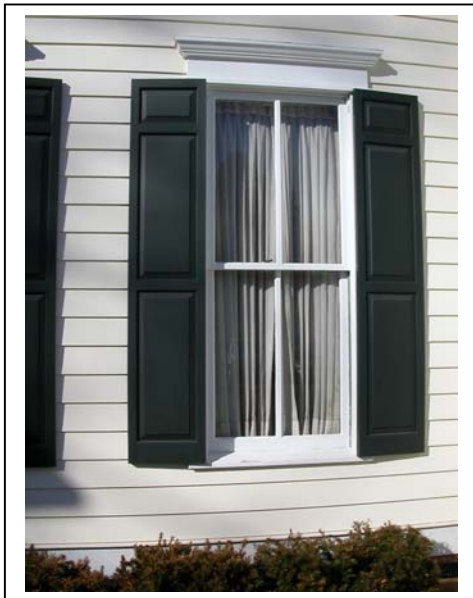
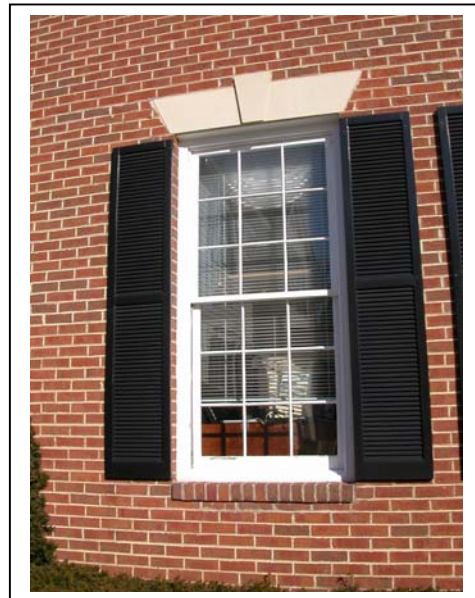
Staff notes that the existing windows appear to be in good, operating condition. There is some peeling paint on some of the windows, and on some of the sills.

Staff recommends the applicant withdraw this application and undertake normal maintenance work at the property.

- 1) Applicant apply for a Certificate of Approval for the installation of storm windows at the property to upgrade energy efficiency of the existing wood windows.
- 2) Applicant either remove the vinyl porch railings and replace with the approved wood railings; or, apply for a Certificate of Approval for the installation of vinyl porch railings.
